# INDOOR AIR QUALITY ASSESSMENT

**East Brookfield Municipal Building  
Depot Square  
East Brookfield, Massachusetts**

Prepared by:  
Massachusetts Department of Public Health  
Bureau of Environmental Health Assessment  
Emergency Response/Indoor Air Quality Program  
April 2003

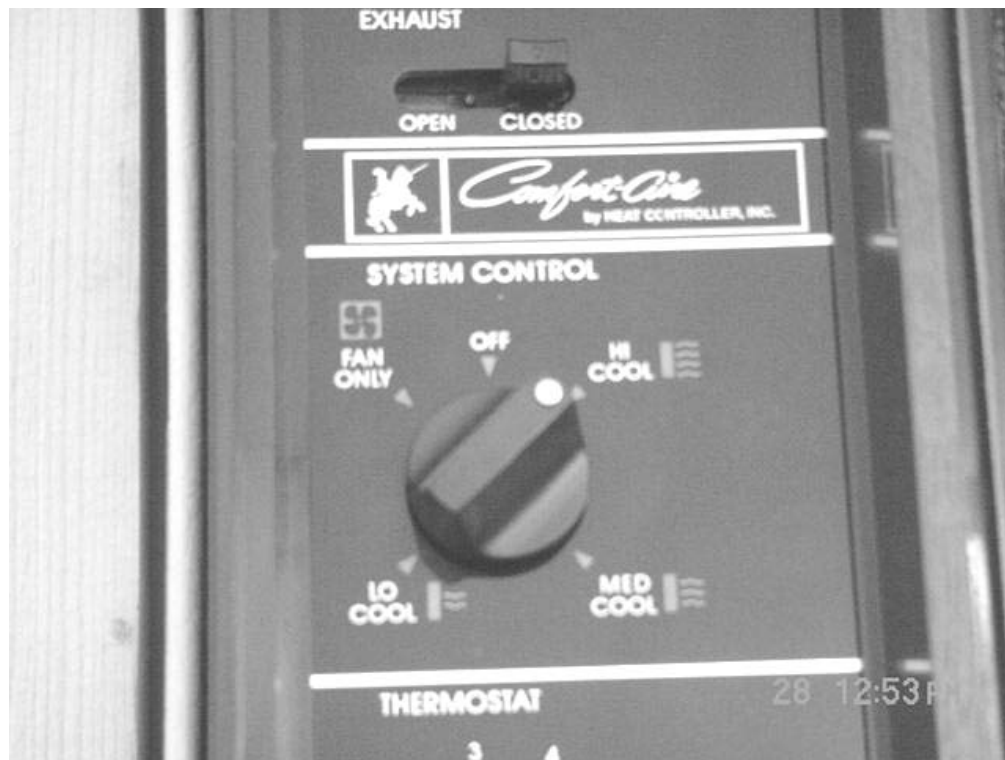
Picture 1

All of the air conditioners examined were equipped with a “fan only” or “exhaust open” setting (see Picture 1). In this mode of operation air conditioning units can provide air circulation by delivering outside air into space without cooling (i.e. air provided by unit equals that of outside temperature).

Control Panel for Window-Mounted AC, Note “Fan Only” Setting

7. This building was designed to use windows to provide fresh air. In order to temper room temperature and provide fresh air, the opening of windows is recommended.

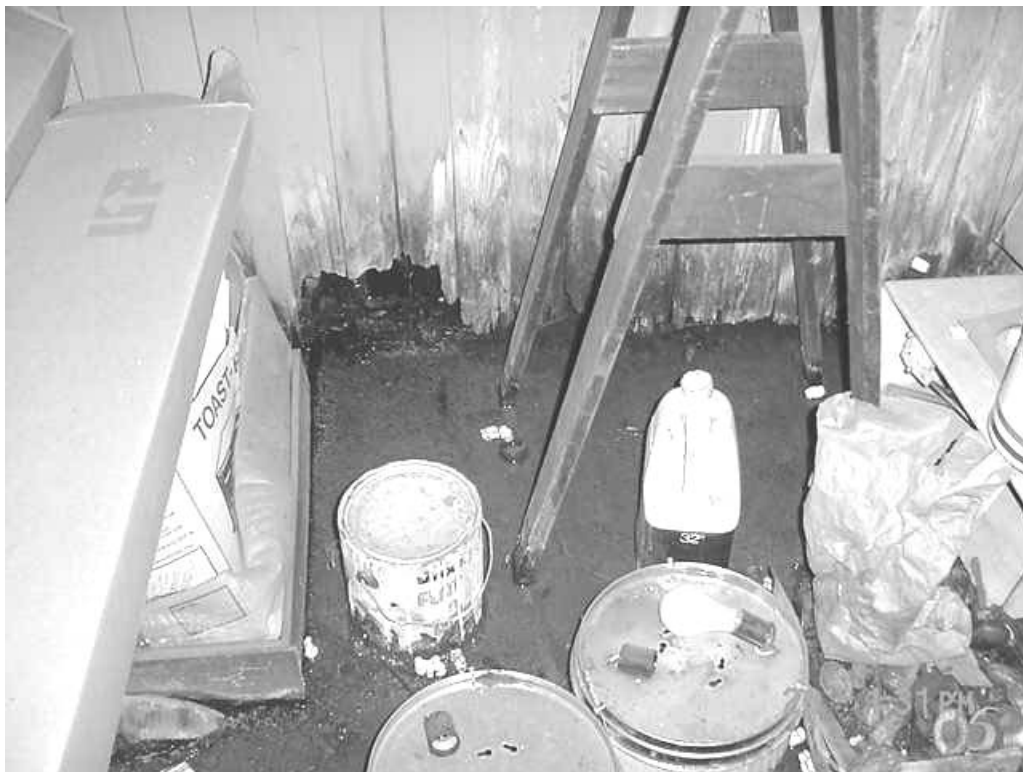
**Picture 2**

As previously mentioned, a focus of occupant concern is the basement, which has reportedly been prone to flooding over the years. A number of moisture sources and water-damaged materials exist in the basement. BEHA staff observed one to two inches of standing water in several basement areas on the day of the assessment. Portions of the basement were divided by the construction of a wooden wall that was severely water damaged to the point where its base had disintegrated (see Picture 2). Porous materials that can support mold growth, such as books, cardboard, paper and ceiling tiles (stacked in piles on the basement floor) chronically exposed to moisture, have resulted in mold growth (see Pictures 2-4).

**Severely Water Damaged, Mold Colonized Wooden Wall in Basement**

1. Remove any mold-contaminated materials (e.g. stored items) in the basement. Remove and replace (if necessary) any water damaged/mold colonized building materials. This measure will remove actively growing mold colonies that may be present. Remove mold contaminated materials in a manner consistent with recommendations found in "Mold Remediation in Schools and Commercial Buildings" published by the US Environmental Protection Agency, Office of Air

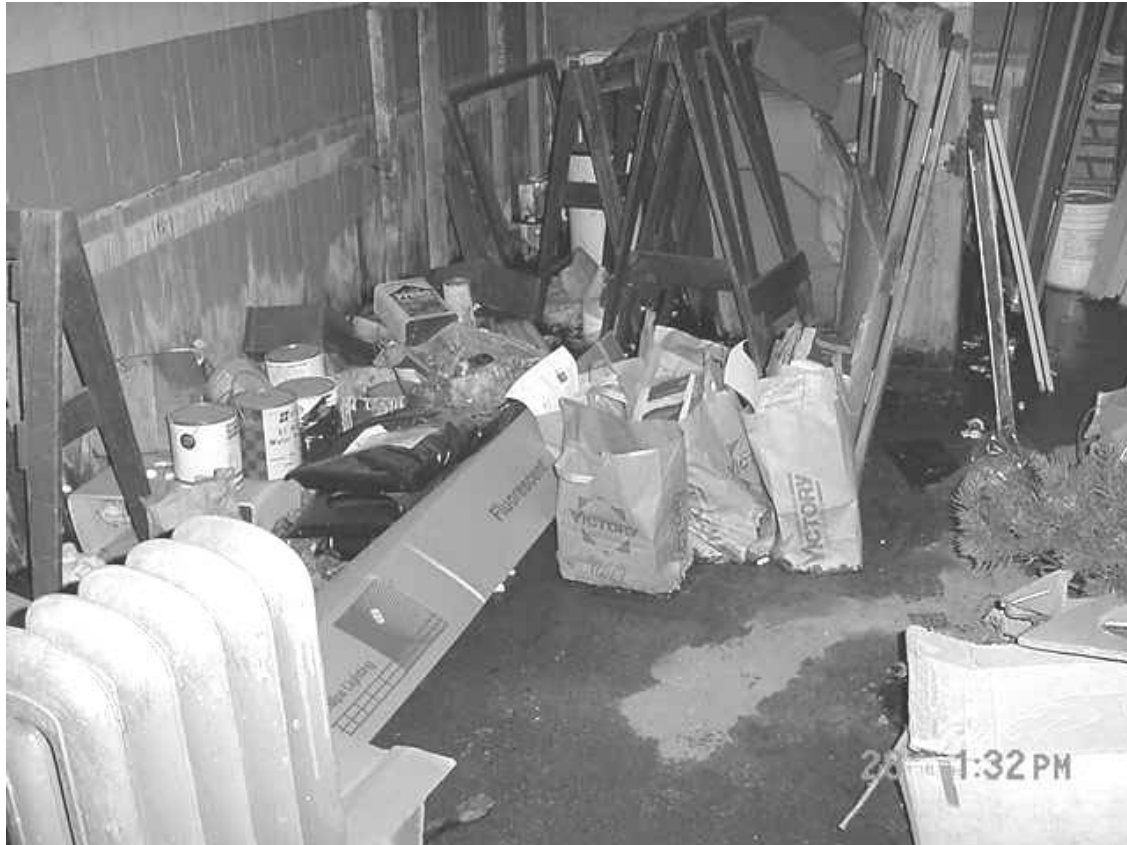
**Picture 3**

**Various Porous Water-Damaged/Mold Colonized Materials in Basement**

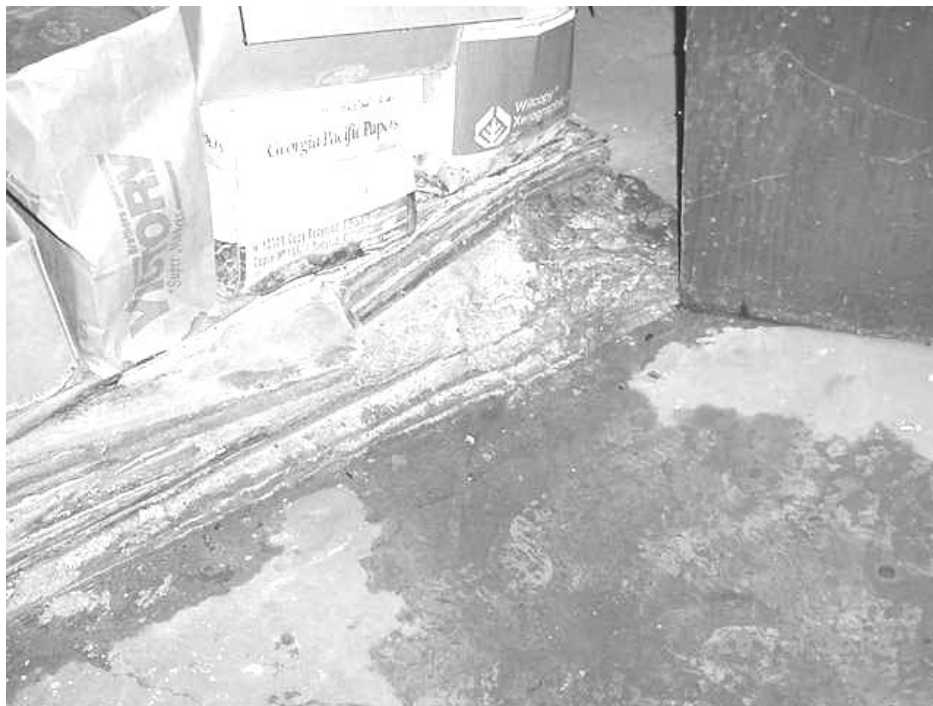
**Picture 4**

**Water-Damaged/Mold Colonized Ceiling Tiles**

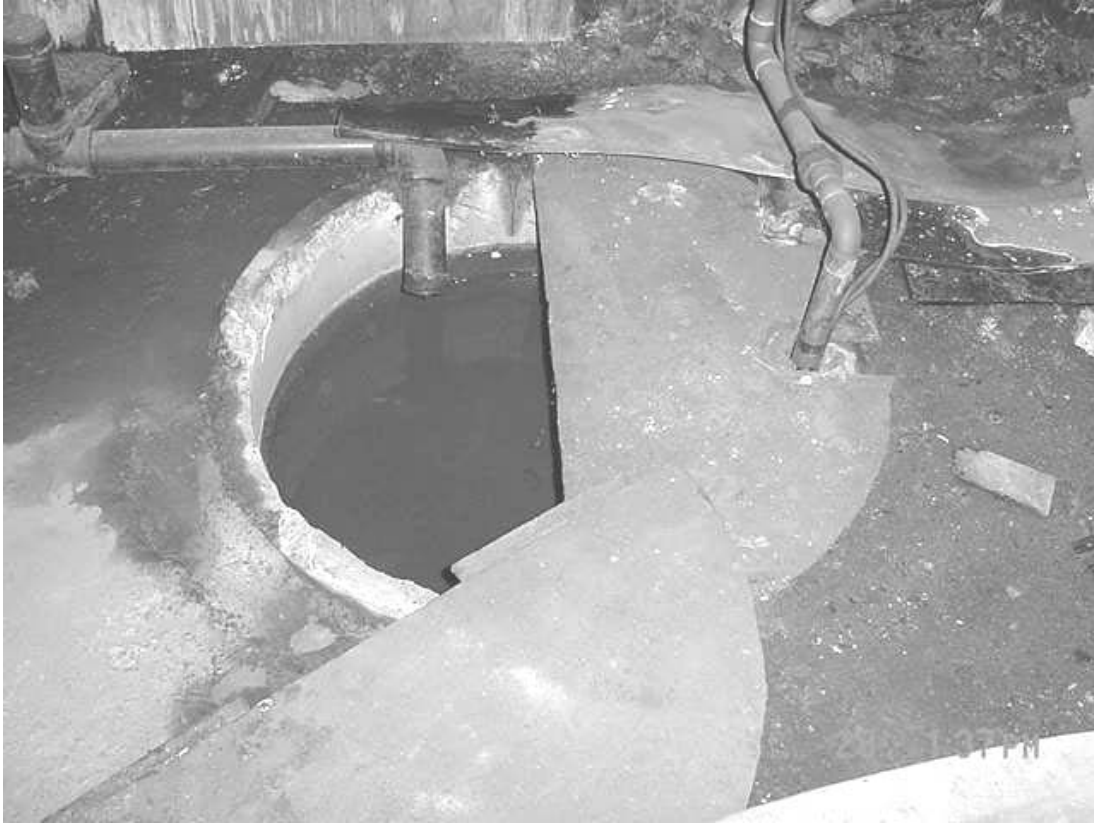
**Picture 5**

Basement flooding in the EBMB appears to be chronic, due to the age and extent of water damaged materials. Although the basement is equipped with a sump pump, it was not clear whether the pump was operable. In addition the pump reservoir was located up gradient to where the standing water was located (see Picture 5). No obvious interior moisture sources were noted. The most likely source of water in the basement is penetration through the foundation/walls. Several potential sources of water penetration into the basement as well as other areas of the building include:

**Sump Pump in Basement**

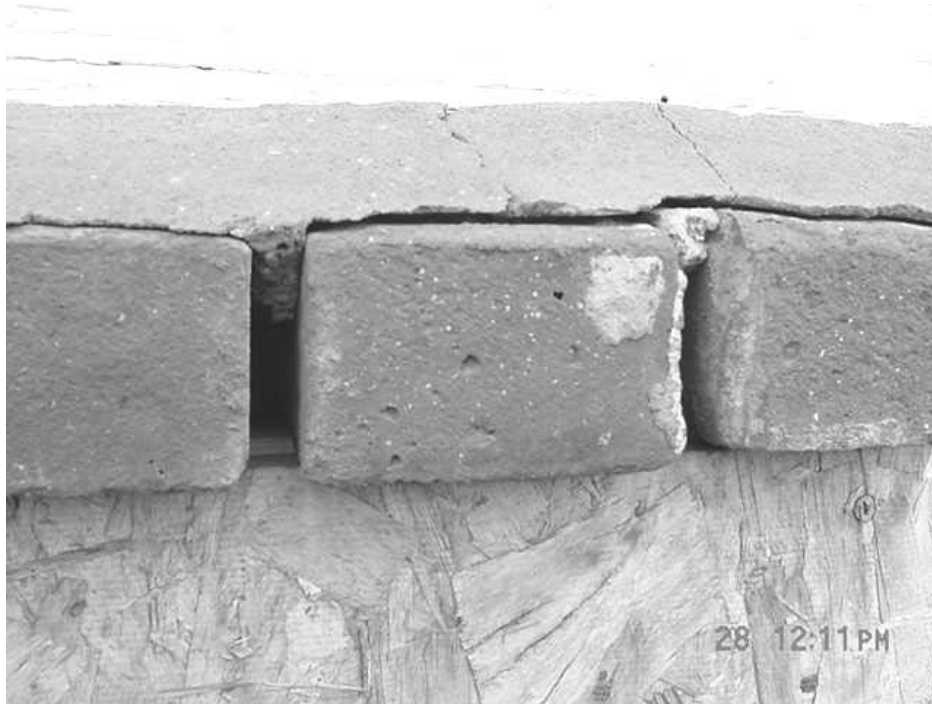
**Picture 6**

- Missing/damaged mortar around bricks (see Picture 6), spaces between concrete stairs and the building were observed (see Pictures 7).

**Missing/Damaged Mortar around Bricks**

1. Consult with an architect and or general contractor regarding the integrity of the building envelope, primarily concerning water penetration through walls and the foundation.
2. Repair and/or replace thermostats as necessary to maintain control of comfort.
3. Consult with an HVAC engineering firm to examine the feasibility of providing mechanical supply and exhaust ventilation in the building.
4. Examine the feasibility of having a downspout/gutter system installed to direct water away from the alleyway.
5. Remove plants from the wall/tarmac junction around the perimeter of the building. Seal the wall/tarmac junction with an appropriate sealer.
6. Ensure all roof leaks are repaired. Once the roof is repaired, repair water damaged plaster and examine the feasibility of repointing brickwork.

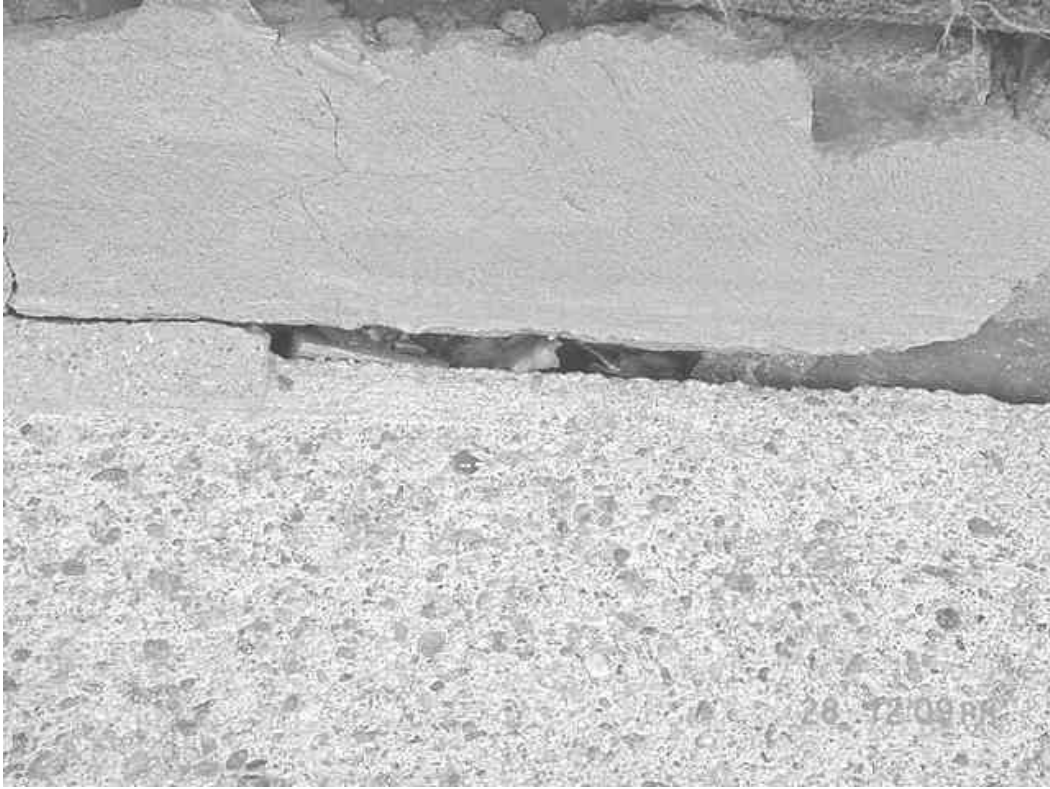
**Picture 7**

**Spaces in Front Concrete Stairwell**

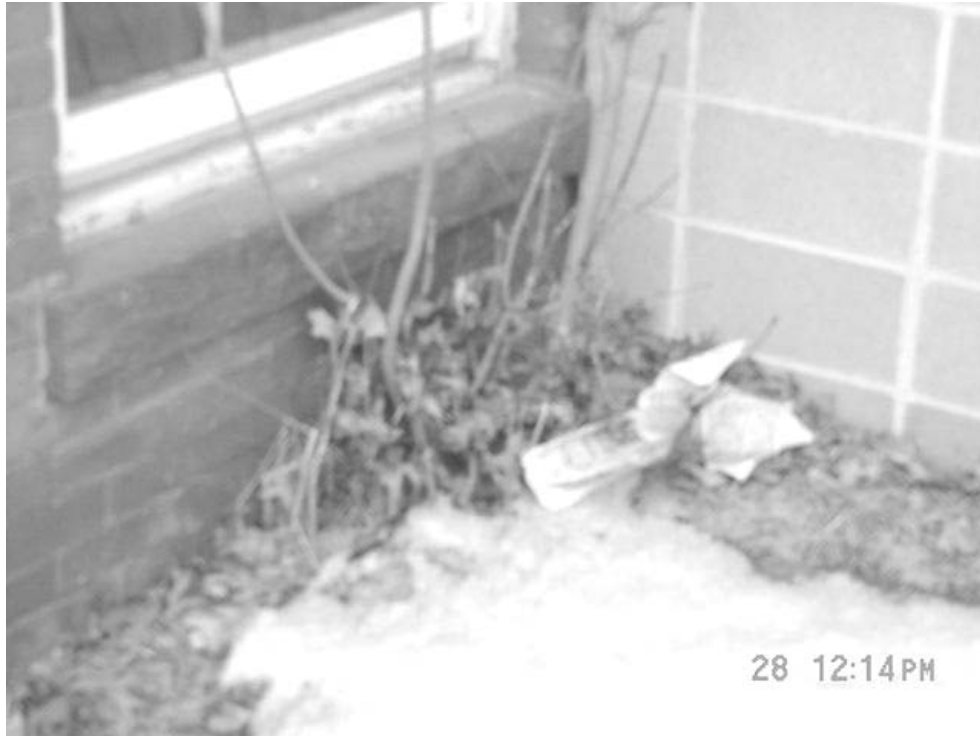
**Picture 8**

- Small trees/stumps, and other plants were growing in the tarmac/exterior wall junction (see Picture 8). The growth of roots/plants against the foundation/exterior walls of the building can bring moisture in contact with wall brick and eventually lead to cracks and/or fissures in the foundation below ground level.

**Small Trees/Plants Growing against the Building**

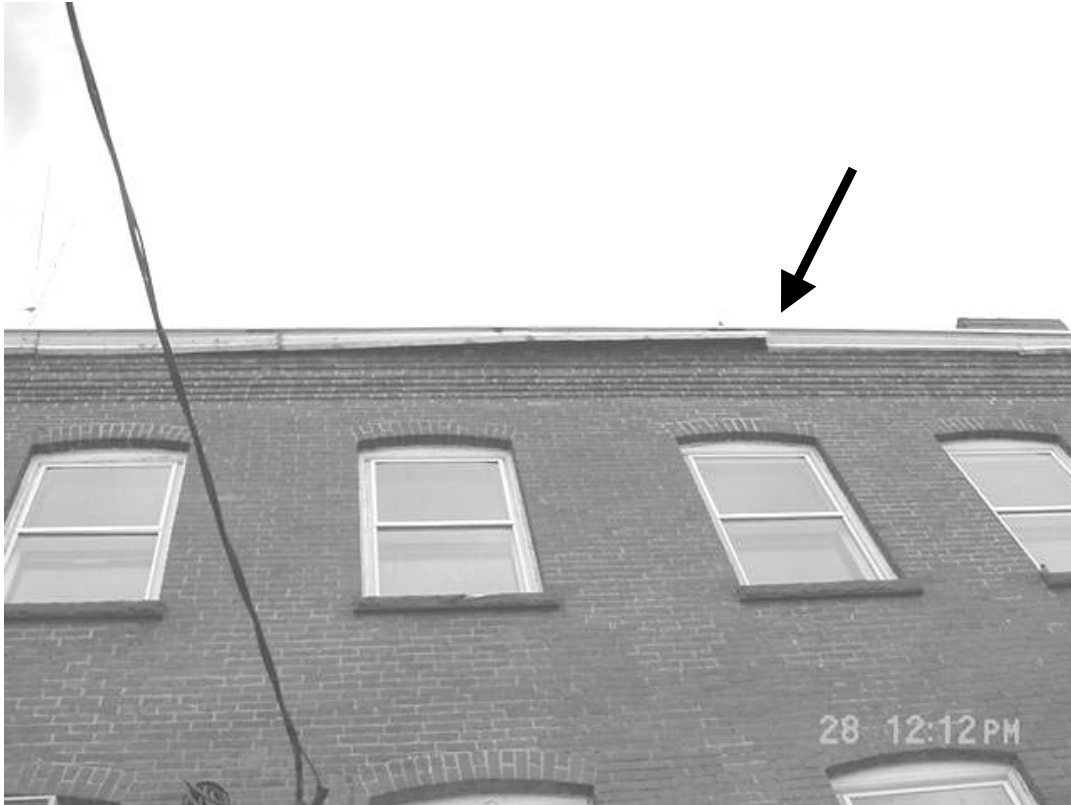
**Picture 9**

- In some areas flashing along the roof was detached from the building (see Picture 9), which can allow wind driven rain to penetrate the building envelope causing water damage to building materials.

**Roof Flashing Detached from the Building**

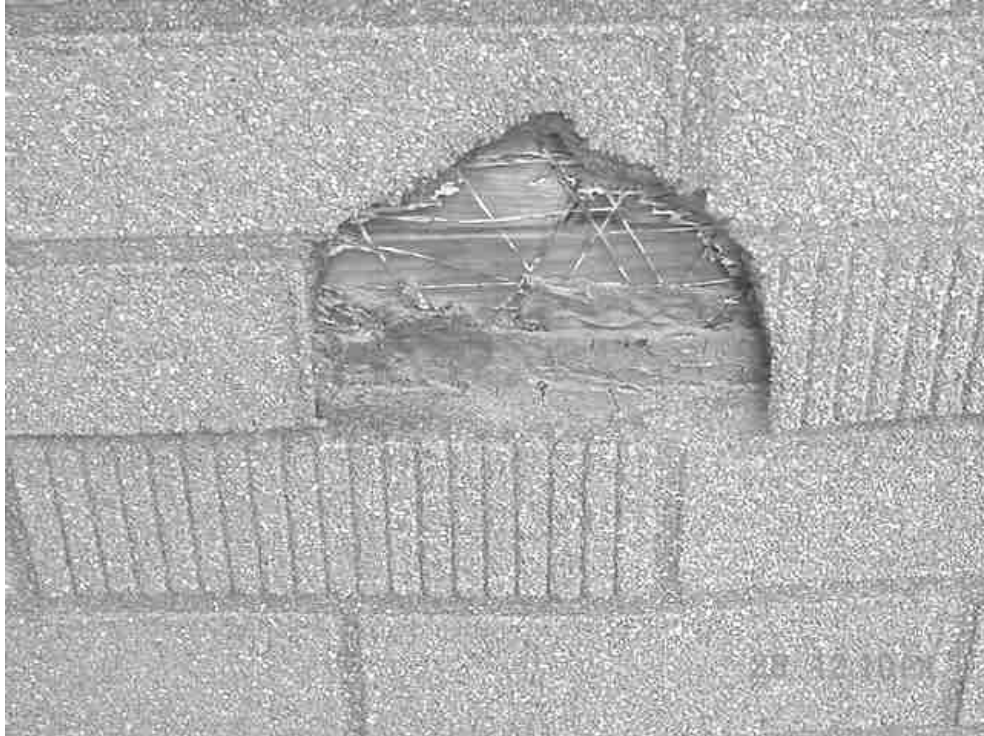
**Picture 10**

- In some areas siding has become detached or completely removed from the exterior of the building (see Picture 10).
- Spaces were noted around exterior doors. Light could be seen penetrating through this space (see Picture 11) and drafts were noted. The floor around the

**Missing/Damaged Siding on Exterior Wall**

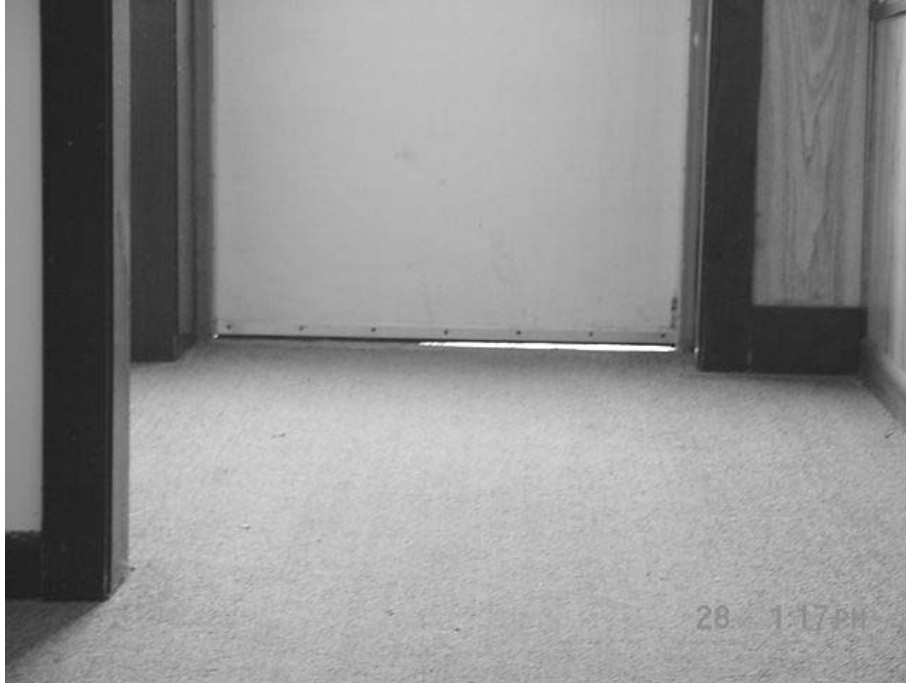
**Picture 11**

rear hallway door is carpeted. Depending on wind and weather conditions, rainwater can penetrate through this space and wet carpeting.

**Spaces beneath Exterior Door Rear Hallway Carpeted Area**

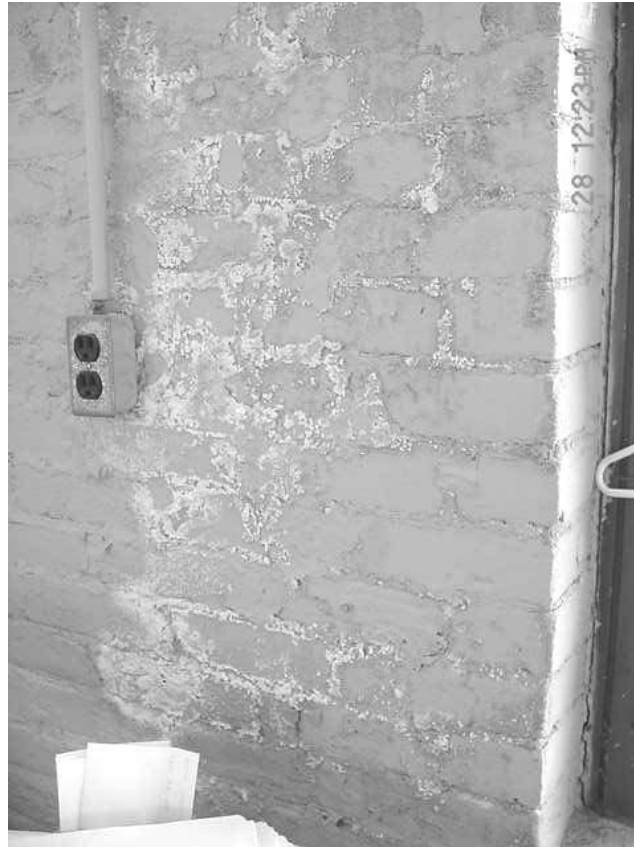
**Picture 12**

A number of areas in the attic and second floor showed signs of efflorescence (see Pictures 12 & 13). Efflorescence is a characteristic sign of water damage to building materials, but it is not mold growth. As moisture penetrates and works its way through building materials, water-soluble compounds dissolve, creating a solution. As this

solution moves to the surface, the water evaporates, leaving behind white, powdery mineral deposits.

**Efflorescence on Attic Brickwork Indicating Water Penetration**

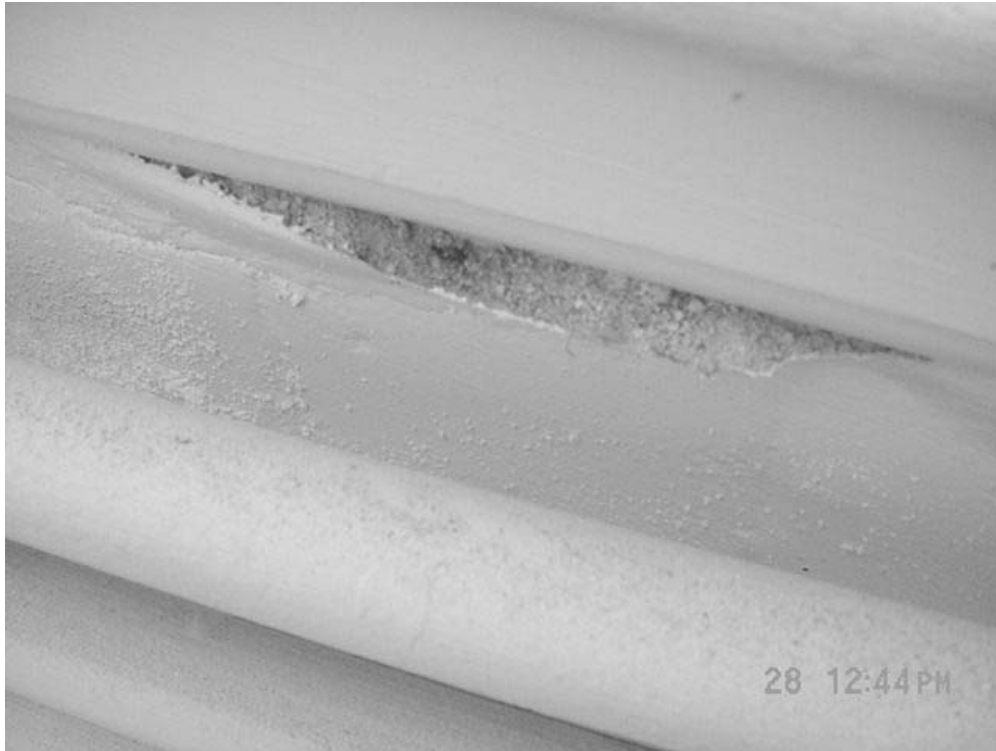
**Picture 13**

**Efflorescence Trapped behind Paint on Interior Brickwork in the Library**

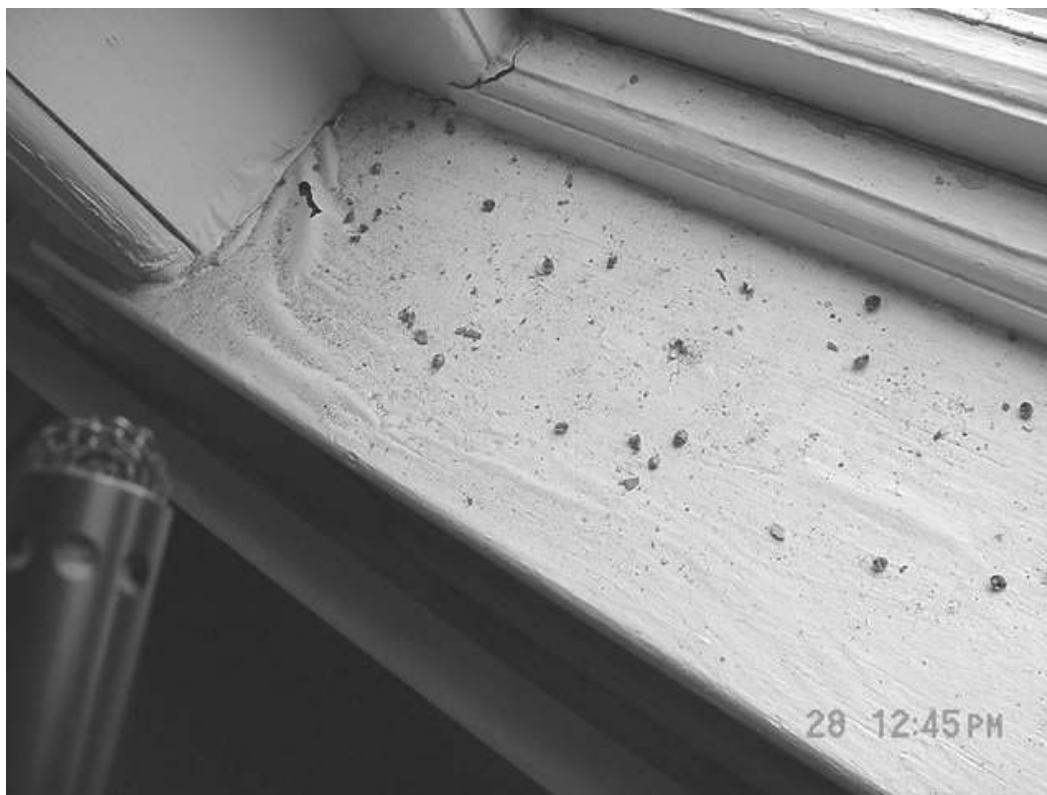
**Picture 14**

Signs of insect infestation were also observed. A number of insect bodies were noted on windowsills in the library (see Picture 14). Insect parts can dry and become aerosolized and may serve as a source of allergenic material for sensitive individuals. The most likely route for insect penetration into the building is through breaches in the building envelope (holes, cracks, etc). The reduction/elimination of pathways of egress into the building should be the first step taken to eliminate this infestation.

**Insect Bodies on Library Windowsill**

12. It is highly recommended that the principles of integrated pest management (IPM) be used to rid this building of pests. A copy of the IPM recommendations can be downloaded from the Internet at [http://www.state.ma.us/dfa/pesticides/publications/IPM\\_kit\\_for\\_bldg\\_mgrs.pdf](http://www.state.ma.us/dfa/pesticides/publications/IPM_kit_for_bldg_mgrs.pdf).

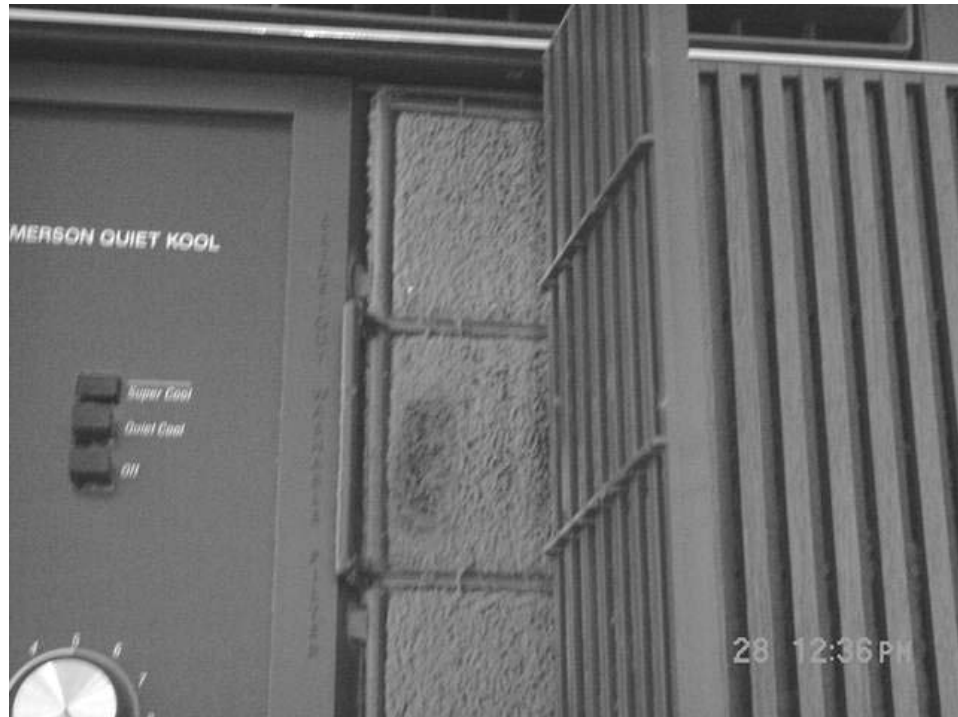
**Picture 15**

As discussed, a number of areas had window-mounted air conditioning units. BEHA staff inspected filters in several of these units and found them coated with dirt/dust (see Pictures 15). Without cleaning/changing filters, the activation of these units can re-aerosolize dirt, dust and particulate, which can be irritating to certain individuals.

**AC Filter Occluded With Dust and Debris**

13. Change/clean filters for air conditioning units as per the manufacturer's instructions or more frequently if needed.

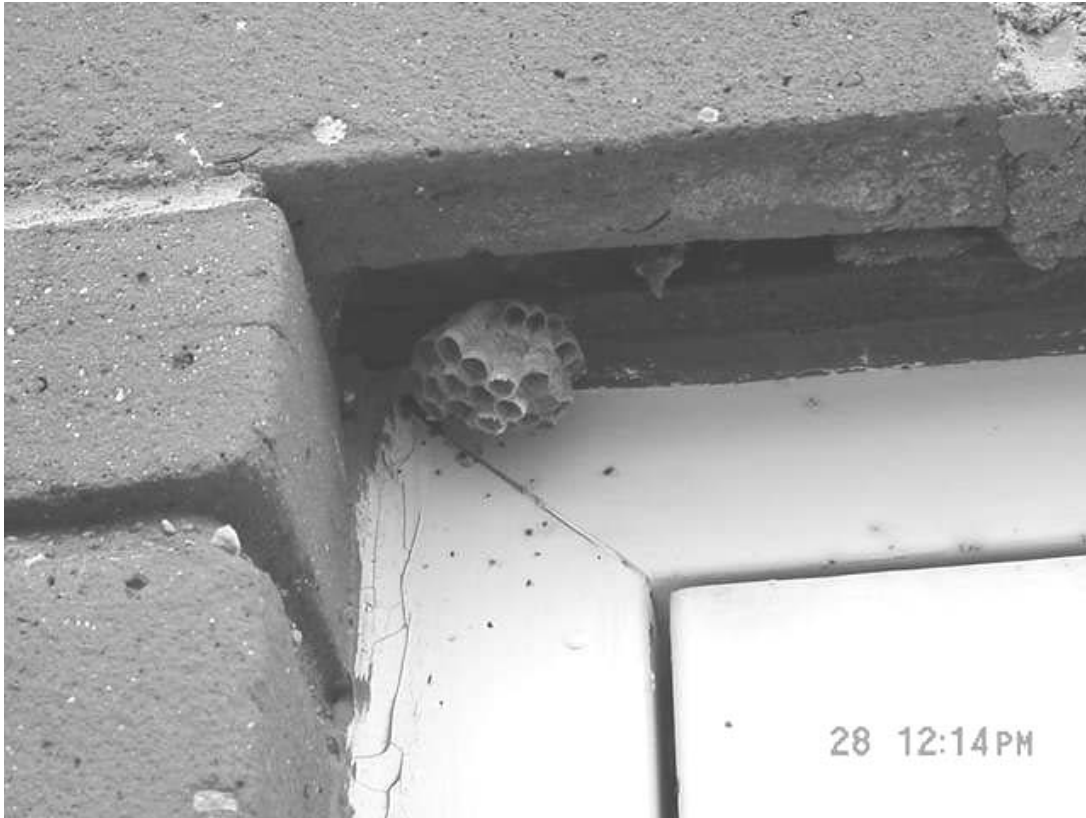
**Picture 16**

Finally, a number of wasps' nests were observed along the perimeter of the building (see Picture 16). Under current Massachusetts law that, effective November 1, 2001, the principles of integrated pest management (IPM) must be used to remove pests in state buildings and grounds (Mass Act, 2000).

**Wasp's Nest along Exterior of the Building**
